# UNDERWATER BRIDGE INSPECTION REPORT

STRUCTURE NO. 2519

CSAH NO. 22

RUM RIVER

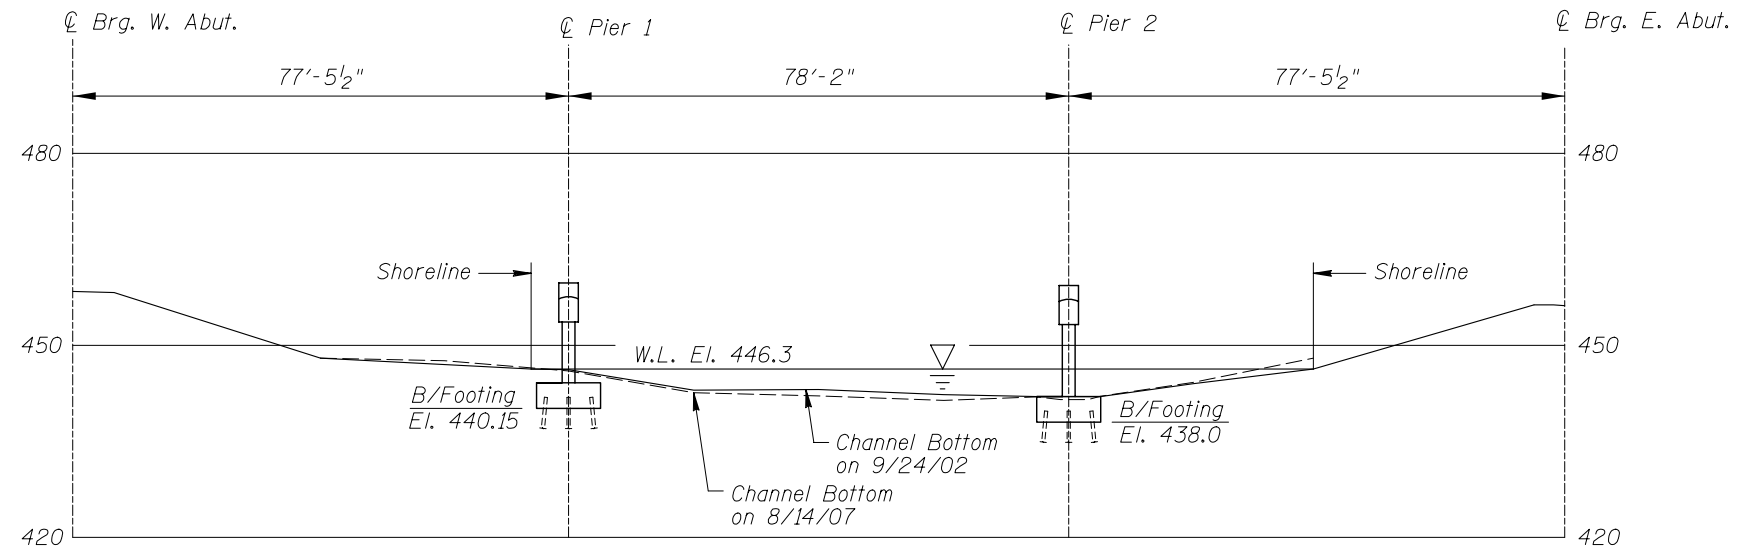
UPSTREAM FASCIA PROFILE

1. The channel bottom material consisted of sand with scattered 2 to 12 inch cobbles.
2. A band of light scaling was observed from 1 foot above to 6 inches below the waterline around both piers with typical penetrations of 1/16 inch and maximum penetrations of 1/8 inch. Above and below the band of scaling the concrete was smooth and sound.

3. The top of the footing was exposed at 1.9 feet below the waterline along the east face of Pier 1 from upstream quarter point to downstream quarter point with no vertical exposure observed.

5. A moderate accumulation of timber debris was observed at the upstream nose of Pier 2, consisting of 8 inch diameter and smaller branches extending from the channel bottom up 3 feet and 8 feet long (East-West) by 3 feet wide (North-South).

6. A 20-foot-long by 2-foot-diameter log was observed along the east face of Pier 2 on the channel bottom.

\* Consideration can be given to removal of the timber debris accumulated around Pier 2 during normal maintenance operations, especially if it is found to be increasing in the future.
